DEPARTMENT OF TRANSPORTATION**DIVISION OF ENGINEERING SERVICES**

Quality Assurance and Source Inspection

Contract #: 04-0120F4Cty: SF/ALA Rte: 80 PM: 13.2/13.9File #: 1.28**WELDING INSPECTION REPORT****Resident Engineer:** Casey, William**Address:** 333 Burma Road**City:** Oakland, CA 94607**Report No:** WIR-029529**Date Inspected:** 27-Mar-2013**Project Name:** SAS Superstructure**OSM Arrival Time:** 700**Prime Contractor:** American Bridge/Fluor Enterprises, a JV**OSM Departure Time:** 1730**Contractor:** American Bridge/Fluor Enterprises, a JV**Location:** Jobsite**CWI Name:** See below**CWI Present:** Yes No**Inspected CWI report:** Yes No N/A**Rod Oven in Use:** Yes No N/A**Electrode to specification:** Yes No N/A**Weld Procedures Followed:** Yes No N/A**Qualified Welders:** Yes No N/A**Verified Joint Fit-up:** Yes No N/A**Approved Drawings:** Yes No N/A**Approved WPS:** Yes No N/A**Delayed / Cancelled:** Yes No N/A**Bridge No:** 34-0006**Component:** OBG**Summary of Items Observed:**

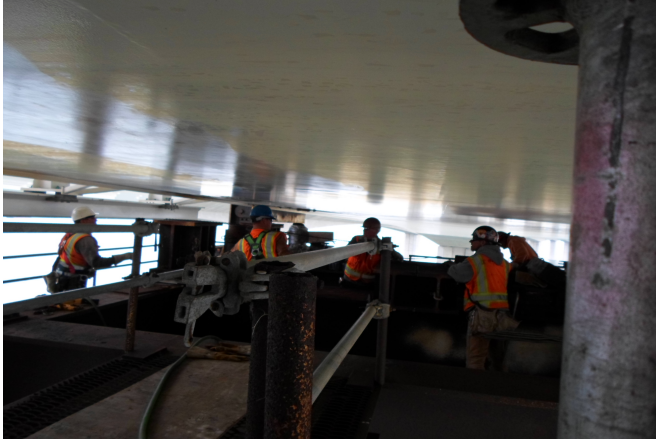
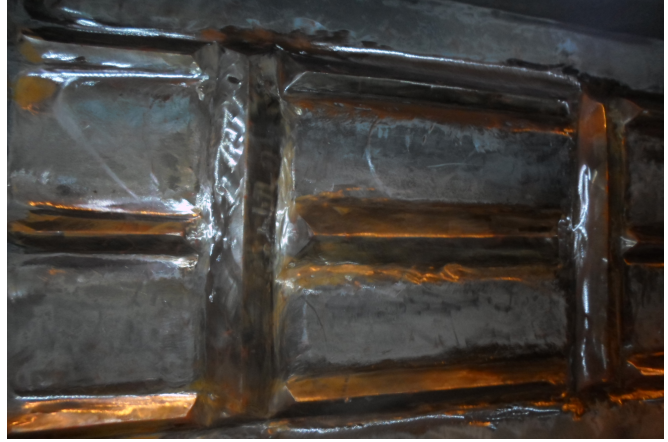
The digital photographs on page three (3) of this report illustrates some of the work activities observed on this date:
